Contract #: 04-0120F4Cty: SF/ALA Rte: 80 PM: 13.2/13.9File #: 1.28**WELDING INSPECTION REPORT****Resident Engineer:**Siegenthaler, Peter**Address:** 333 Burma Road**City:** Oakland, CA 94607**Report No:** WIR-023232**Date Inspected:** 29-Apr-2011**Project Name:** SAS Superstructure**OSM Arrival Time:** 700**Prime Contractor:** American Bridge/Fluor Enterprises, a JV**OSM Departure Time:** 1530**Contractor:** American Bridge/Fluor Enterprises, a JV**Location:** Job Site**CWI Name:** Steve Jensen**CWI Present:** Yes No**Inspected CWI report:** Yes No N/A**Rod Oven in Use:** Yes No N/A**Electrode to specification:** Yes No N/A**Weld Procedures Followed:** Yes No N/A**Qualified Welders:** Yes No N/A**Verified Joint Fit-up:** Yes No N/A**Approved Drawings:** Yes No N/A**Approved WPS:** Yes No N/A**Delayed / Cancelled:** Yes No N/A**Bridge No:** 34-0006**Component:** SAS Tower**Summary of Items Observed:**

Caltrans Office of Structural Material (OSM) Quality Assurance Inspector (QAI) Joselito Lizardo was present at the Self Anchored Suspension (SAS) job site as requested to perform observations on the welding of components for the San Francisco Oakland Bay Bridge (SFOBB) Project.

At To

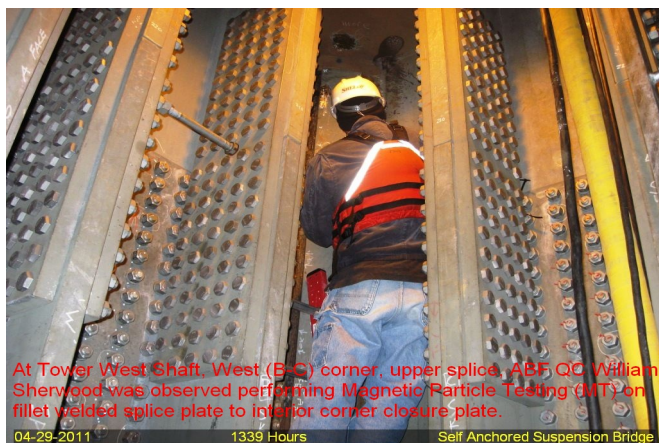
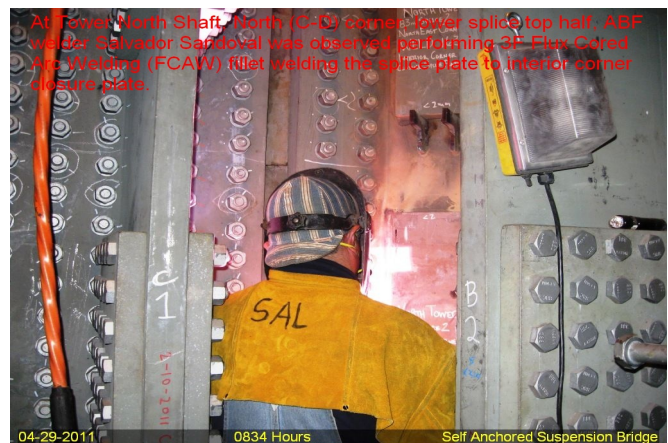
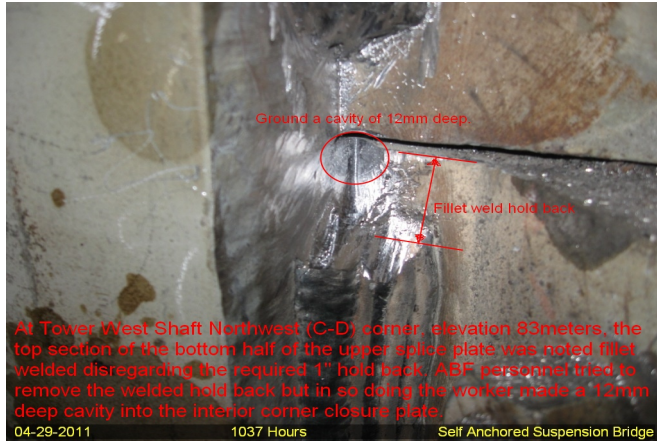
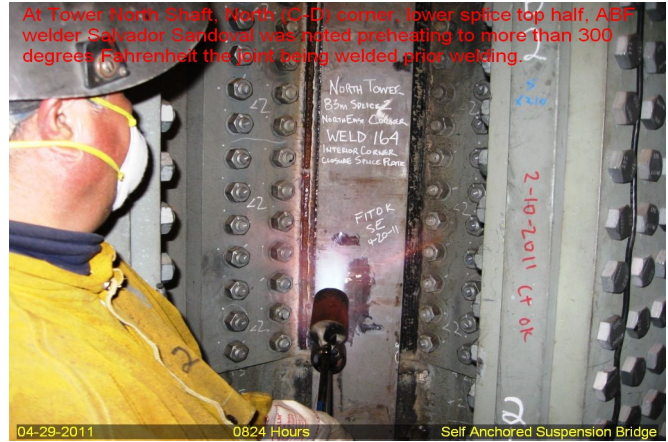
At Tower West Shaft Splice #2 @Elevation 83meters:

At the request of Quality Control Field Supervisor, Bonifacio Daquinag, QA has randomly verified the QC VT of the fillet welded lower and upper splice plate joints. During the QA verification, the following observations were noted;

1. At Northwest (C-D) corner of upper splice plate, the top section of the bottom half vertical fillet on two sides of the plate were fillet welded disregarding 1" hold back before the interior closure plate splice.
2. ABF QC Steve Jensen has visually accepted the welded 1" hold back disregarding this same specific requirement.
3. ABF personnel have tried to grind off the welded hold back but in so doing they ground excessively into the interior closure plate leaving a cavity of at least 12mm deep.

Due to the above infractions that were observed during the VT verification, an Incident Report will be forthcoming.
